White paper

This white paper has been prepared by Nornickel Group following the incident at HPP-3 of NTEK JSC (part of Nornickel Group), which occurred on 29 May 2020.

WHITE PAPER ON NTEC'S HPP-3 INCIDENT CLEAN-UP AND RESPONSE

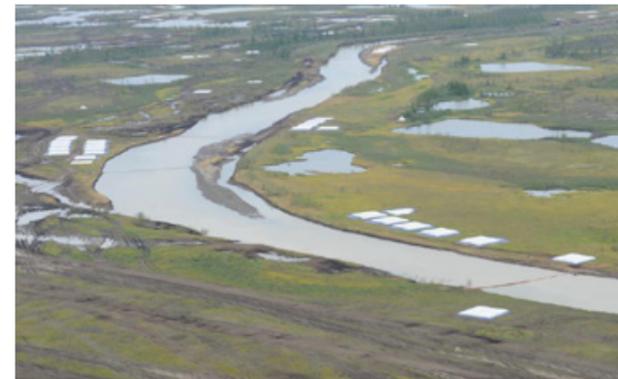
Fig. Booms on the Ambarnaya River

- ▶ 55 booms were deployed, including 16 lines of sorbent booms to prevent further spill into Lake Pyasino and the Kara Sea;
- ▶ over 100,000 tonnes of the contaminated soil was removed from the HPP-3 site;
- ▶ over 32,000 cu m of the water and fuel mixture was collected from the area adjacent to HPP-3 and the Ambarneya River;
- ▶ over 70,000 sq m of the land was treated with sorbents;
- ▶ NTEC's team launched an inspection of the back-up diesel fuel storages with special attention paid to the assessment of risks associated with the subsidence of soil under hazardous facilities.

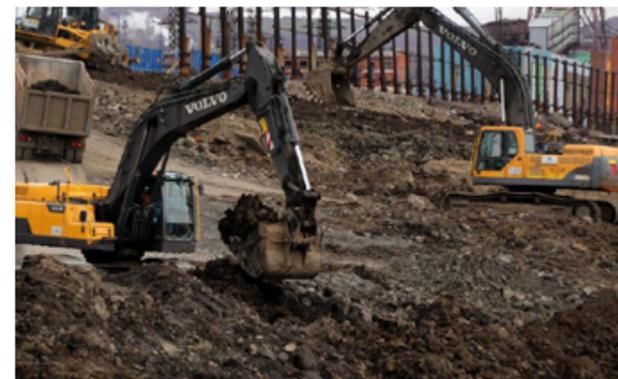
Fig. Contaminated soil collected and removed from the spillage area

Upon excavation, all contaminated soil was collected and transported to roofed hangars with concrete foundations for temporary storage. Lands affected by the excavation were subsequently reclaimed to prepare them for the intended use.

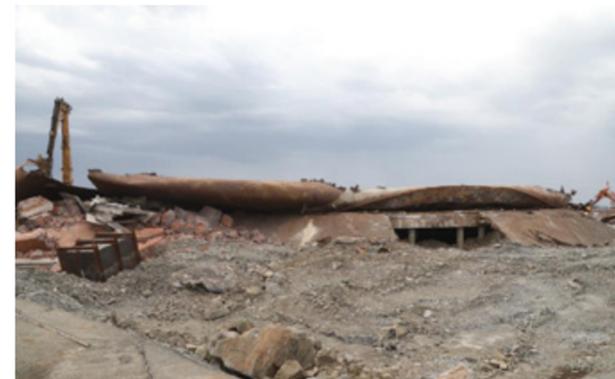
Fig. Disassembly of damaged tank No. 5

On 25 July, NTEC began disassembly of damaged HPP-3 tank following extensive preparation, which included the drafting of a storage tank No. 5 disassembly project by Norilsknickelremont Maintenance and Construction and two specialist organisations.

As part of the preliminary works, the sloping bunds were disassembled, and gravel was brought in and formed to enable machinery transportation and installation. The experts made access holes and fed wire ropes through them to stabilise the damaged roof.

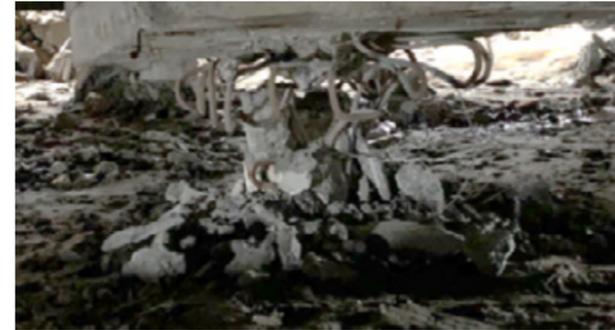
Fig. Failure of some of the reinforced concrete piles which supported the tank.

The incident mainly stems from flaws in the design (1981) and construction (1984) of tank No. 5 leading to overloading and the subsequent destruction of 33 reinforced concrete piles and the foundation which subsided by up to 1.5 m under the tank floor.

The root cause of the tank failure was differential subsidence of its foundation following the destruction of several reinforced concrete piles which supported the tank. This subsidence resulted in a rupture of the tank shell where the wall was welded to the tank floor.

Following its investigation, the regulator reported that some of the piles were found to be shorter than their design length, failing to be installed 800 mm into the bedrock during construction in 1984 as required by design documents and applicable regulations.

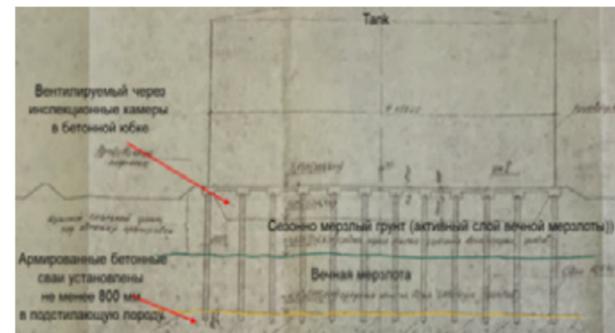
Fig. Tank No. 5 original design drawing dated 1981.

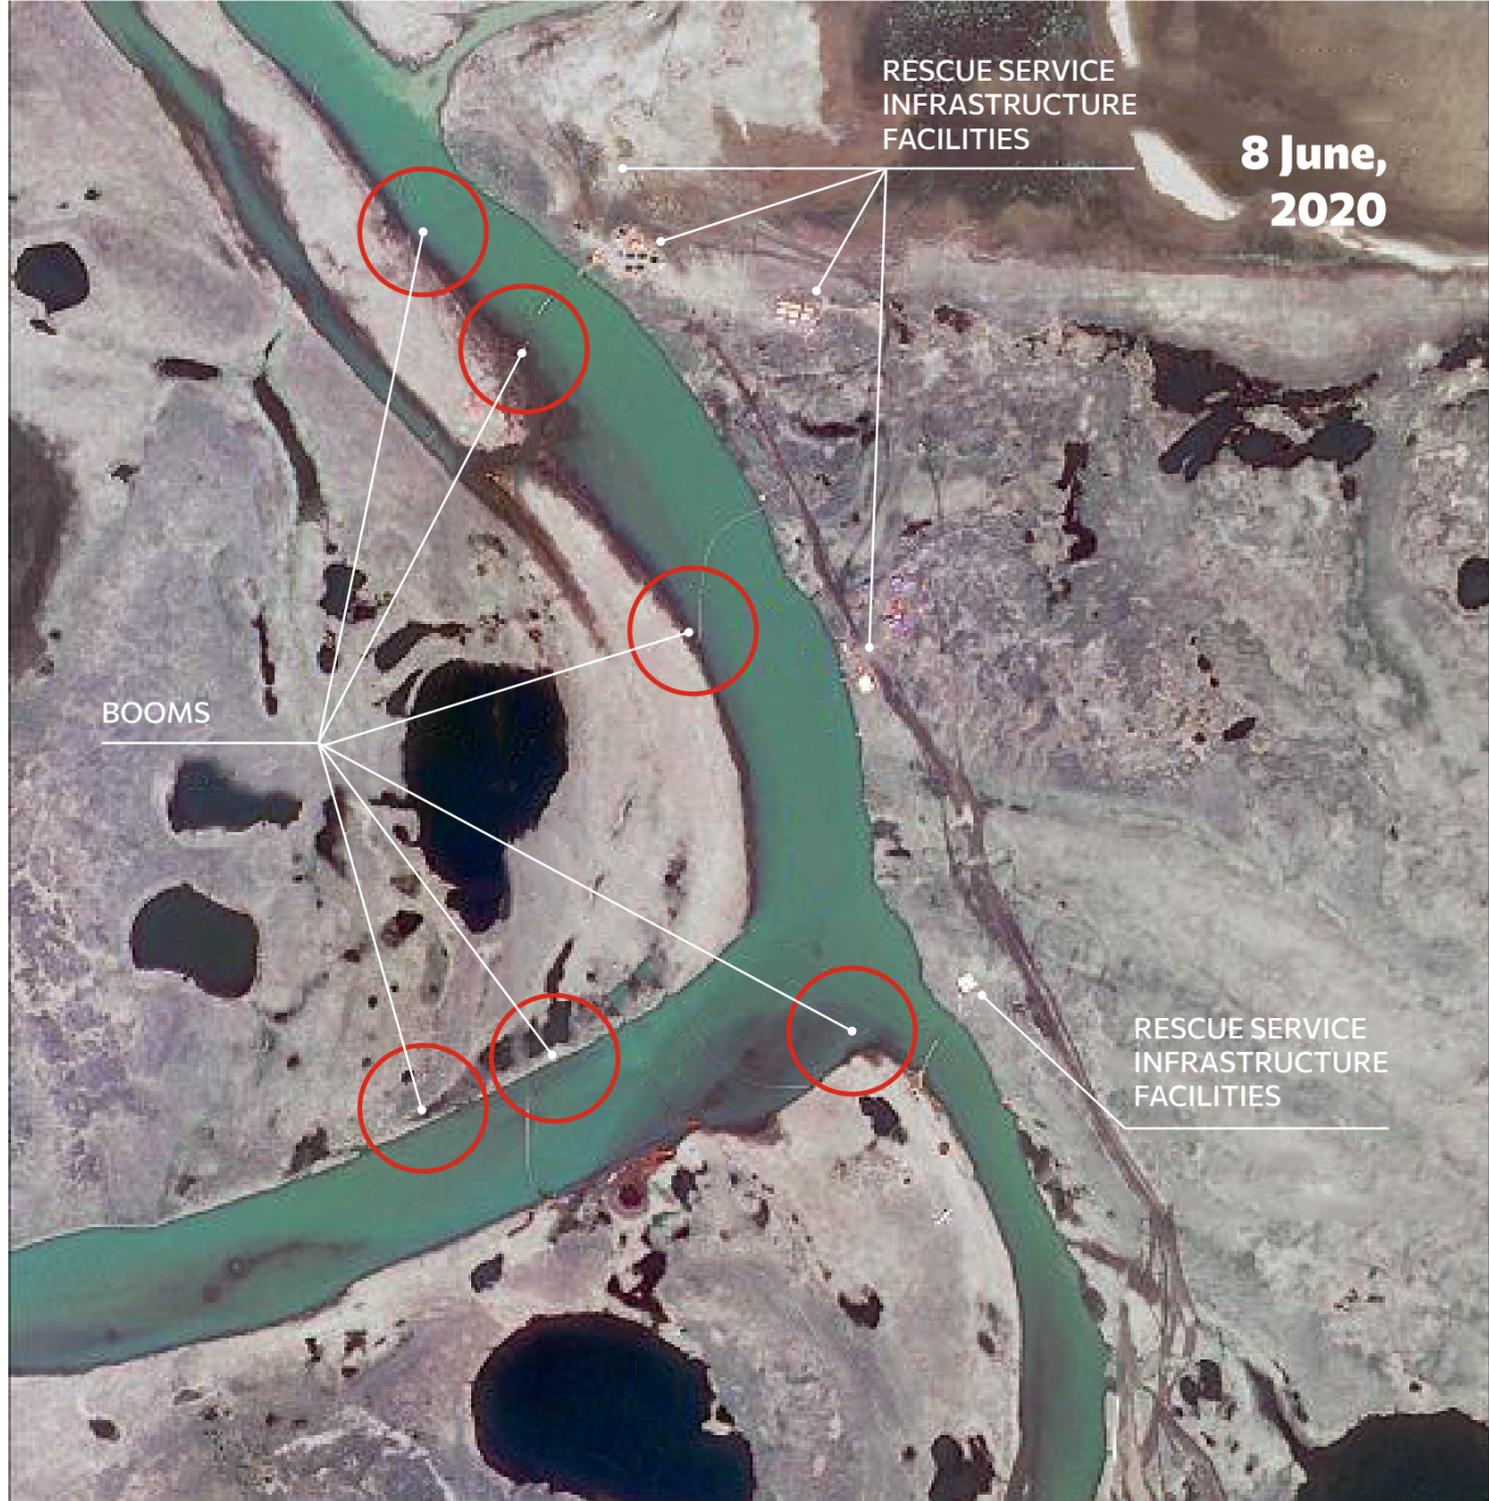
04 June 2020

Monitoring of the fuel spill in Norilsk
Image taken by Resurs-P No. 1 satellite using Geoton opto-electronic technology

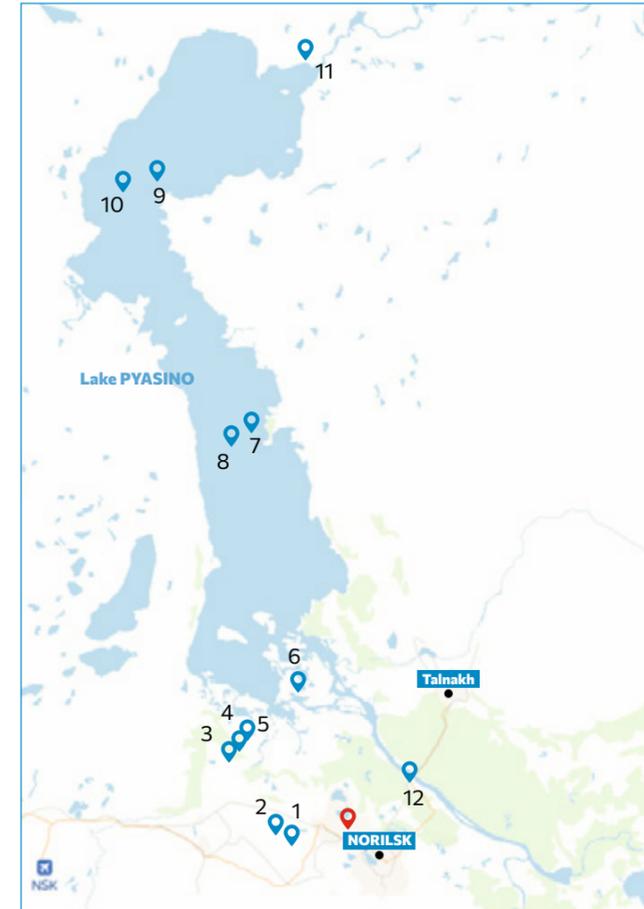
Map of sampling locations

1. Hydrochemical and microbiological study (marks 1–54, Trofimuk Institute of Petroleum Geology and Geophysics, Institute of Oil and Gas Problems)
2. Hydrobiological study (white rectangles in fig. 1, Biophysics Institute)
3. Geochemical and geochronological study of sediments and soils (marks 31–44 and red marks, Sobolev Institute of Geology and Mineralogy, Institute of Oil and Gas Problems (Microbiology))
4. Studies of soil, vegetation and animal species (red rectangles, Science Research Institute of Agriculture and Ecology of the Arctic, Central Siberian Botanical Garden, Sukachev Institute of Forest, Institute of Oil and Gas Problems (Microbiology))
5. Geophysical and permafrost study (blue rectangles, Trofimuk Institute of Petroleum Geology and Geophysics, Melnikov Permafrost Institute)

1. Bezymyanny (Nadezhninsky) Stream near HPP-3
2. Daldykan River (north of the Bezymyanny Stream mouth, background sampling)
3. Daldykan River (mouth area)
4. Ambarnaya River (north of the Daldykan River mouth, background sampling)
5. Ambarnaya River (south of the Daldykan River mouth)
6. Ambarnaya River (mouth area)
7. Lake Pyasino (Cape Tonkiy area, near the shore)
8. Lake Pyasino (Cape Tonkiy area, in the middle)
9. Lake Pyasino (Cape Goly area, near the shore)
10. Lake Pyasino (Cape Goly area, in the middle)
11. Pyasina River (source area)
12. Norilskaya River (background sampling)
