Norilsk Nickel
Update on Recent
Developments
March 29, 2021

Update on Selected Recent Developments

Overview of the Accident at Norilsk Concentrator

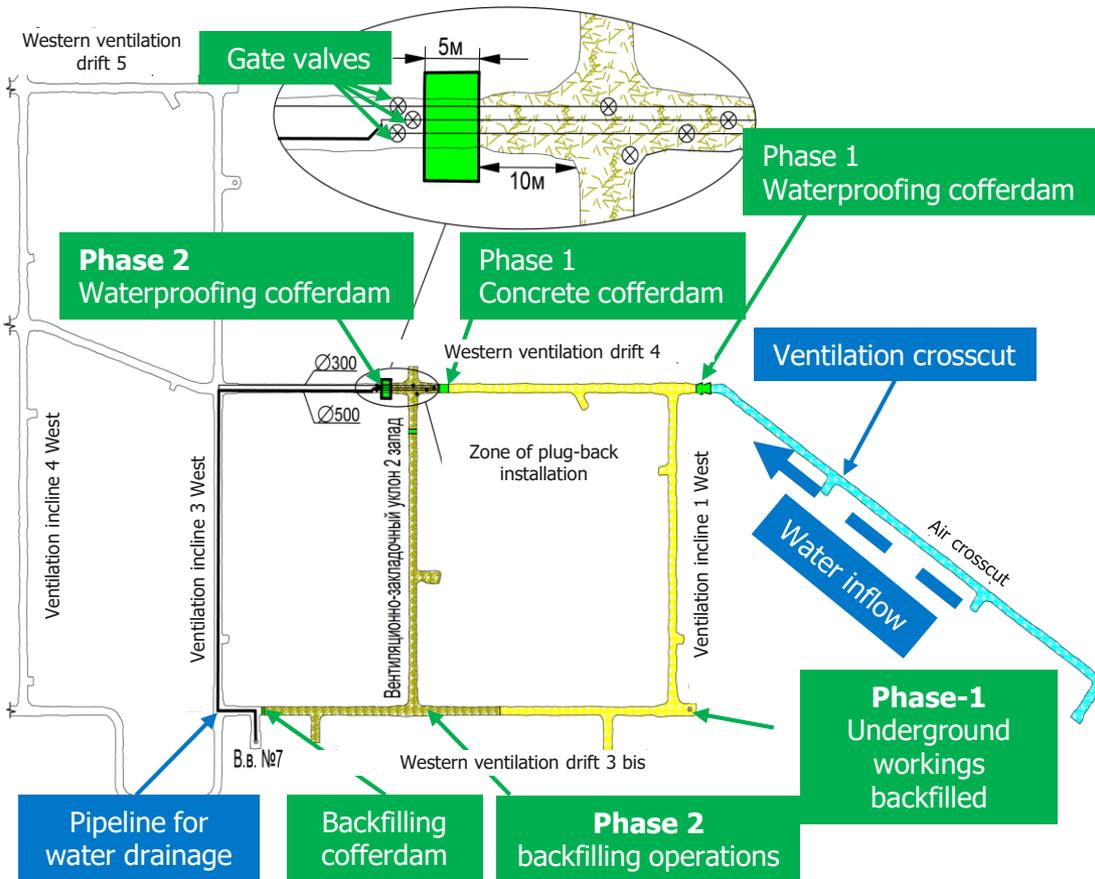
Oktyabrsky Mine: Containment of Water Inflow at the -350 m Level

- ✓ **February 12th** – during tunnelling operations, natural groundwater inflow was detected at the -350m level
- ✓ **March 1st** – a concrete two-section waterproof cofferdam was installed at the ventilation crosscut of the -350m horizon at the Oktyabrskiy mine with drainage pipes and high-pressure shut-off valves for water discharge and water control

- ✓ **March 4-9** – adjacent underground workings were backfilled with hardening mixtures
- ✓ **March 13th** – Phase-1 completed: a waterproofing cofferdam was installed, the backfill mixture hardened and water was drained

- ✓ **March 25th** – the second phase was completed: additional cofferdams were installed, all of the adjacent workings were filled with backfill mix, and water release launched

- ✓ **March 27th** – the gate valves were shut, water inflow was stopped
- ✓ Total volume of concrete backfilled of approximately **32 kt** (Phase 1 -16kt, Phase 2 -16kt)

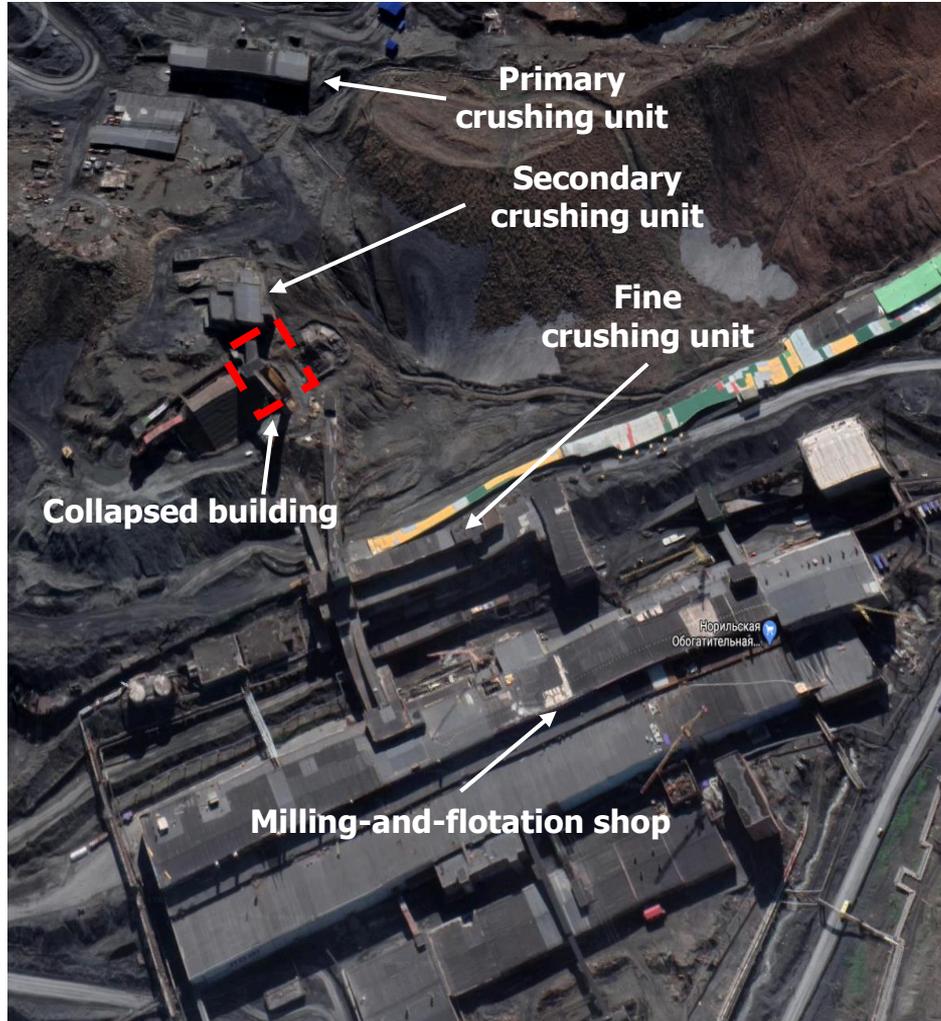
Norilsk Concentrator Layout

- **Total throughput in 2021 (plan) – 9.2 mtpa, including:**
 - ✓ Disseminated ore circuit of 5.2 mtpa
 - ✓ Cuprous ore circuit of 4.0 mtpa
- **Feedstock processed:**
 - ✓ Disseminated ores mined at Norilsk-1 Deposit by Zapolyarny Mine (South Cluster project)
 - ✓ Disseminated and cuprous ores mined at Oktyabrskoye and Talnakh deposits by Mayak, Oktyabrsky and Komsomolsky mines
 - ✓ Tailing of the Copper Plant
- **The accident took place at the disseminated ore circuit.** As the result of the building collapse:
 - ✓ Secondary crushing unit and crushed ore warehouse have been decommissioned
 - ✓ Primary crushing unit was temporarily suspended, as a result of which processing of disseminated ores from the Zapolyarny open pit and Mayak and Komsomolsky mines have stopped

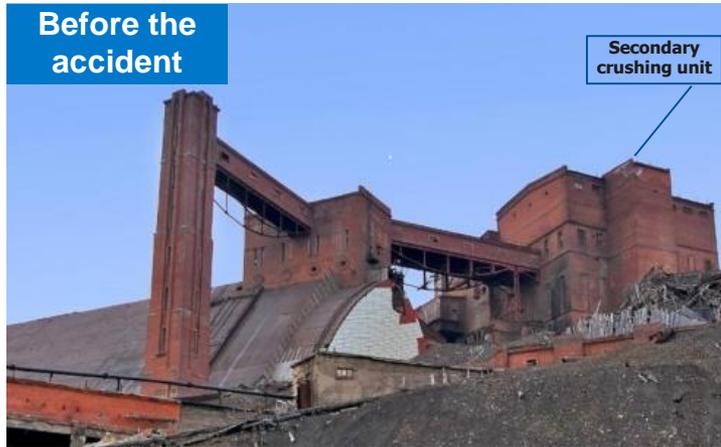
Before the accident

- **Accident:** on February 20th, the building of the ore reloading facility, secondary crushing unit, collapsed during repairs
- **Preliminary causes of the accident:**

- ✓ Gross violations of safety rules
 - ✓ Safety instructions of the repair works were not followed and operation of the building, which was in critical technical condition, was continued

- ✓ Free passage of repair and maintenance staff to the site of work through a dangerous area was allowed
- **Immediate response:**
 - ✓ Comprehensive technical expert assessment of buildings and structures of the ore crushing shop

- ✓ Update on safe walkways within the ore crushing shop, of which all employees of Norilsk Concentrator have been notified
- **Accelerated upgrade and technical audit:**

- Completion of repairs and upgrade of the disseminated circuit is scheduled **from April 15th**.
 - ✓ The decision to relaunch will be made jointly with the regulator (Rostekhnadzor) upon technical inspection
