**Update on the Clean-up Following the Accident
at a Fuel Storage of Norilsk Nickel**

October 2020

HPP-3 Incident Overview

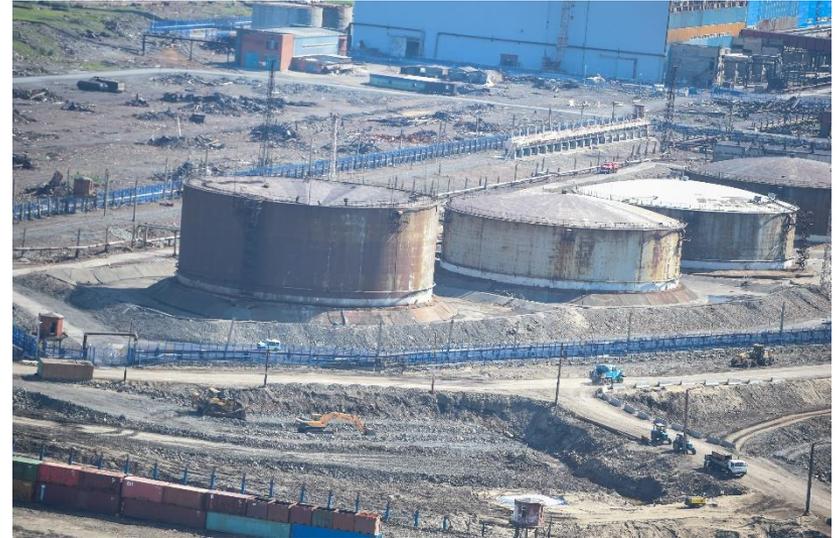
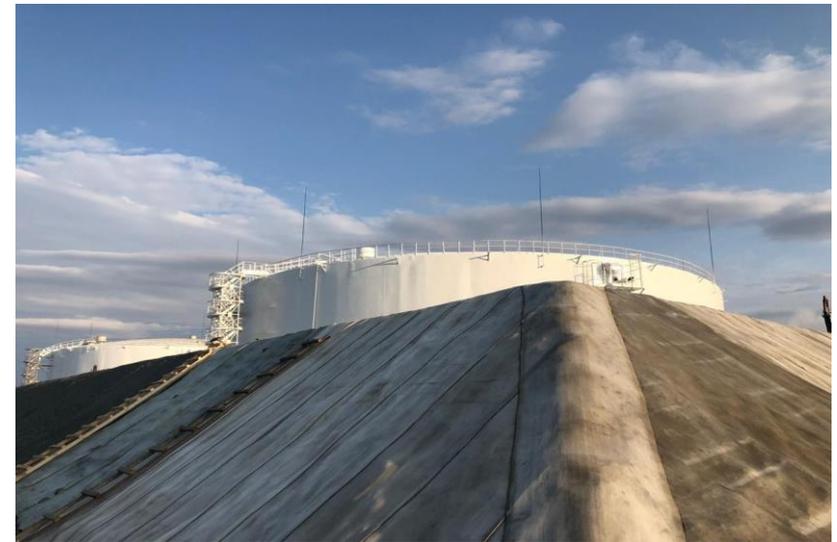
- HPP-3 is operated by Norilsk Nickel's wholly-owned subsidiary, Norilsk Taymir Energy Company (NTEC)
- HPP-3 predominantly serves the local municipality of the Norilsk Industrial District and supplies some power to Norilsk Nickel's facilities
- HPP-3 consumes natural gas, with diesel fuel used only in emergencies and stored in fuel reservoirs
- The reservoir #5, where the incident took place, was built in 1985
- After undergoing capital repairs in 2017-2018, the reservoir #5 went through hydraulic testing and Industrial Safety Audit (ISA) in 2018
- All recommendations of ISA regarding filling the reservoir #5 for the first time after the repairs were followed and controlled

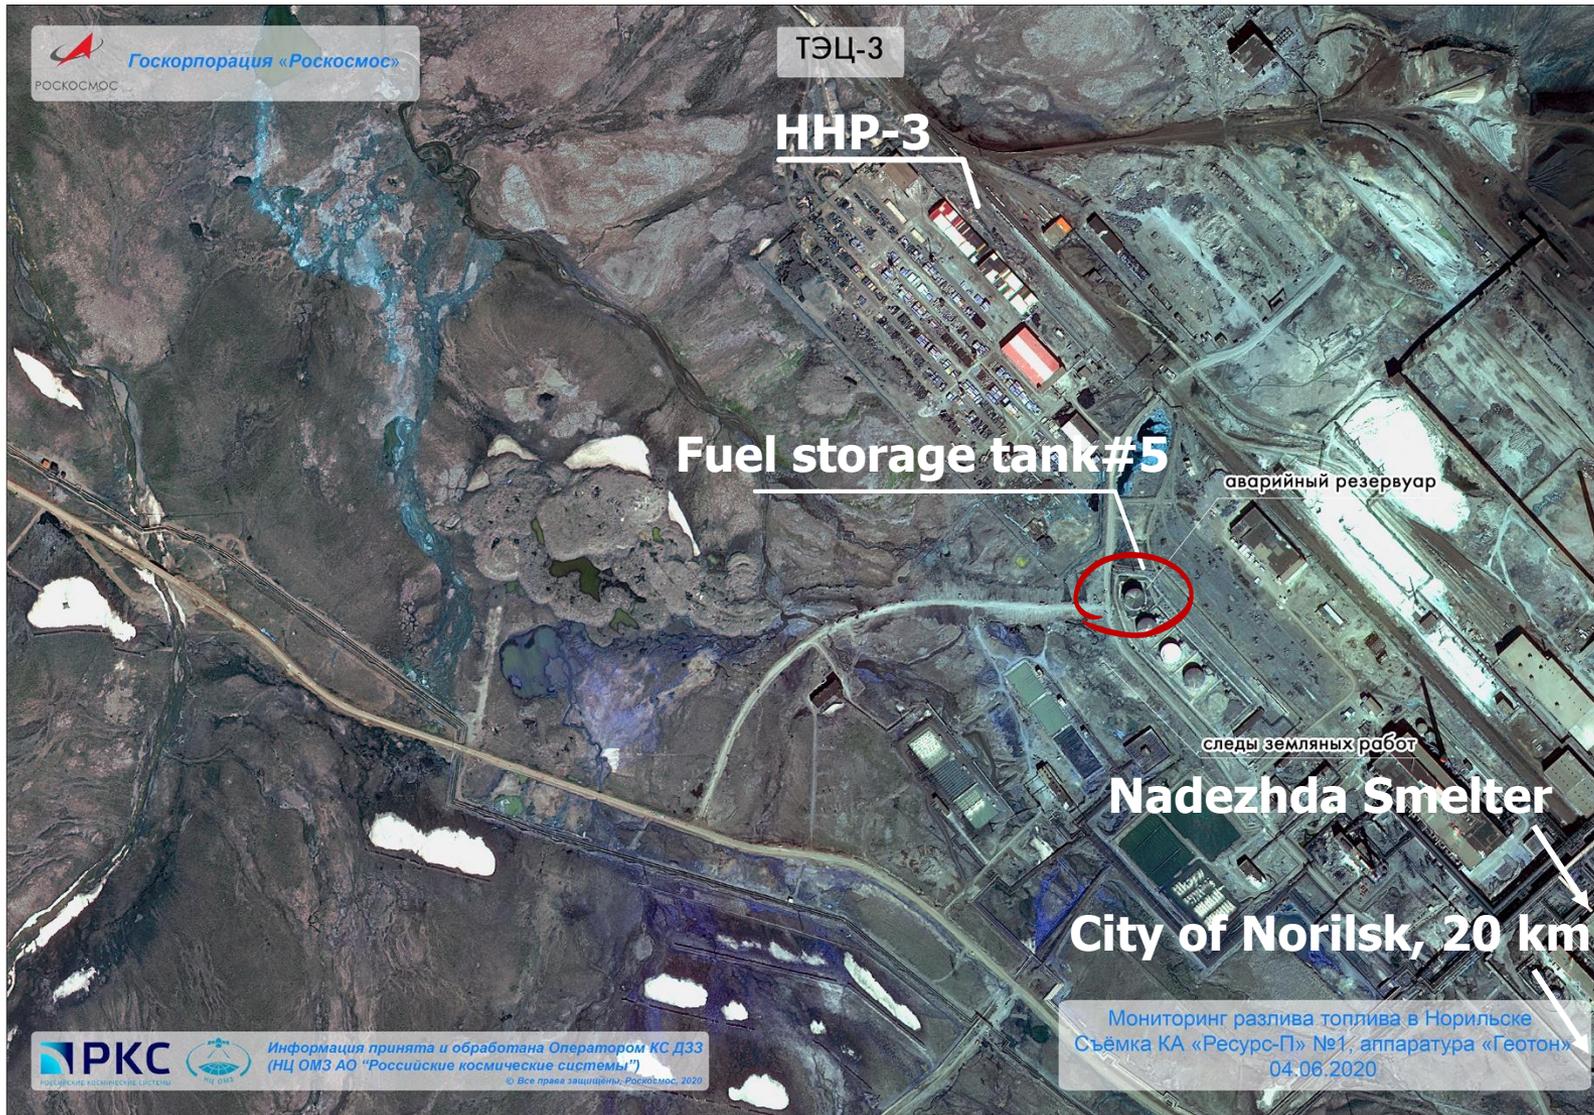
ROSKOSMOS Satellite Images of HHP-3 and Damaged Fuel Tank

According to the project design of 1981, the fuel reservoir #5 was supposed to be built on a concrete platform resting on 160 support posts sunk into permafrost and dug into a rock bed

According to the preliminary assessment, the incident has been caused by a combination of factors, which triggered sinking of several support posts under the basement of the fuel tank#5:

- ✓ Faults in the construction of the facility (finished in 1985)
- ✓ Thawing of permafrost

Technical investigation has already revealed that several of the support posts were shorter than designed length and in violation of the project design were not resting on the rock bed underneath the reservoir

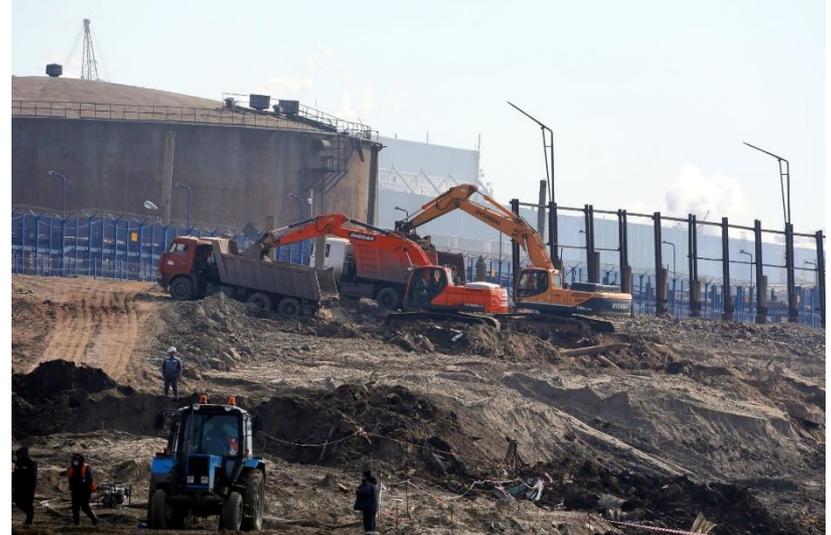
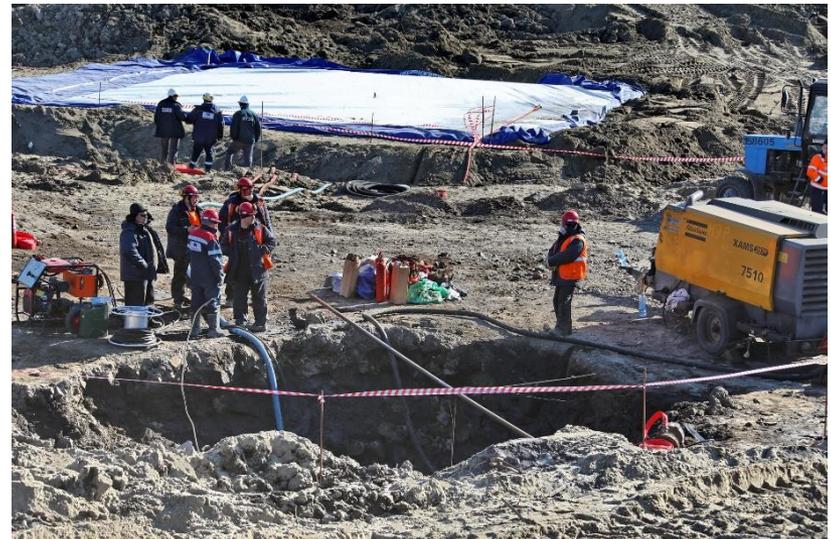
- ✓ **Clean-up was launched immediately after the incident on May 29th**
- ✓ **By the end of September, all of the contaminated soil (189 kt) was removed** and hauled for temporary storage into sealed-off hangars to prevent further risk to the environment
- ✓ A system of drainage shafts (sumps) arranged to collect fuel
- ✓ Approximately 9k cubic meters of water-fuel mixture was collected near HPP-3
- ✓ Rehabilitation of disturbed land near the HHP-3 (grass seeding) launched
- ✓ Teams deployed to remove the contaminated soil: Norilsk Nickel

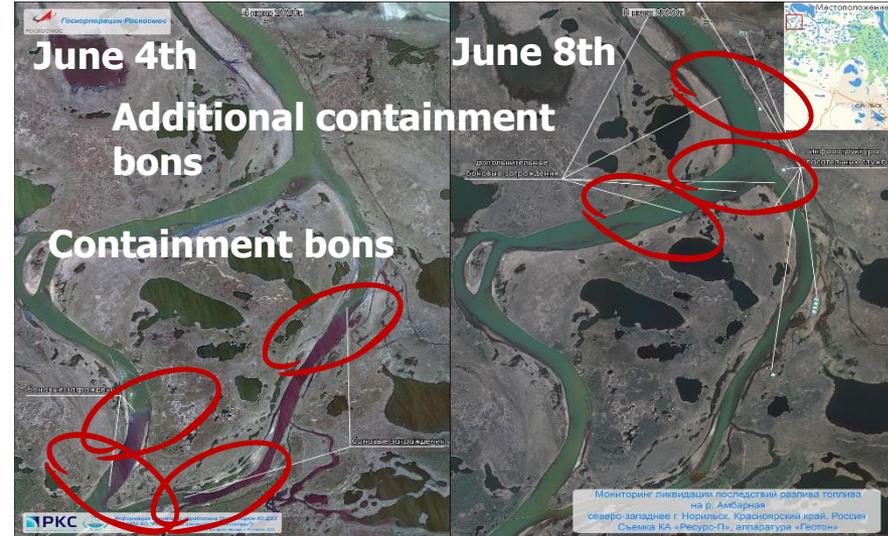
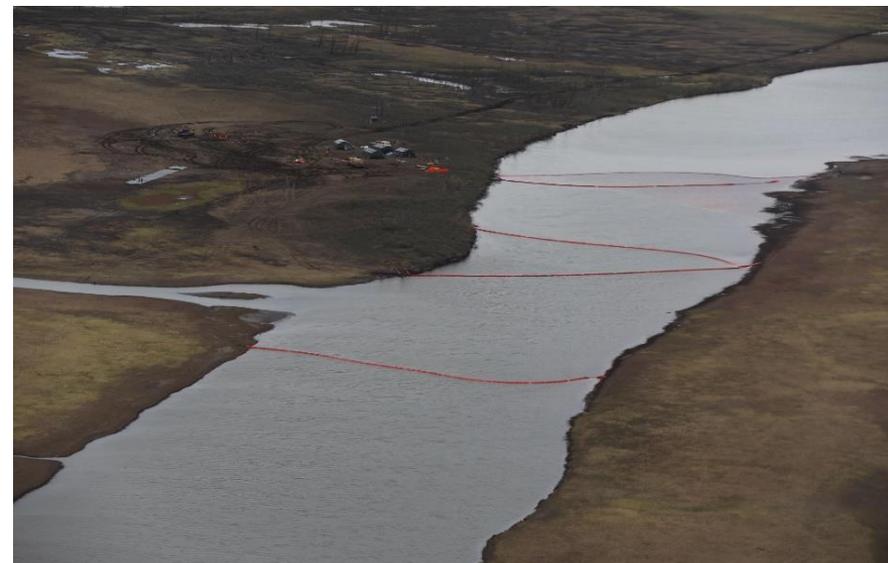
- **Clean-up of water and prevention of further fuel spread and water contamination**
 - ✓ Containment and absorbent boms were rolled out in the river Ambarnaya, 110 lines, 3.4km long as of the end of September
 - ✓ A total of almost 26k cubic meter of water-fuel mixture was collected from the Ambarnaya river
 - ✓ The water-fuel mixture was placed into 117 watertight tanks
 - ✓ Teams deployed to clean-up water spill: the Marine Rescue Service (from Murmansk), Gazpromneft, Transneft and EMERCOM

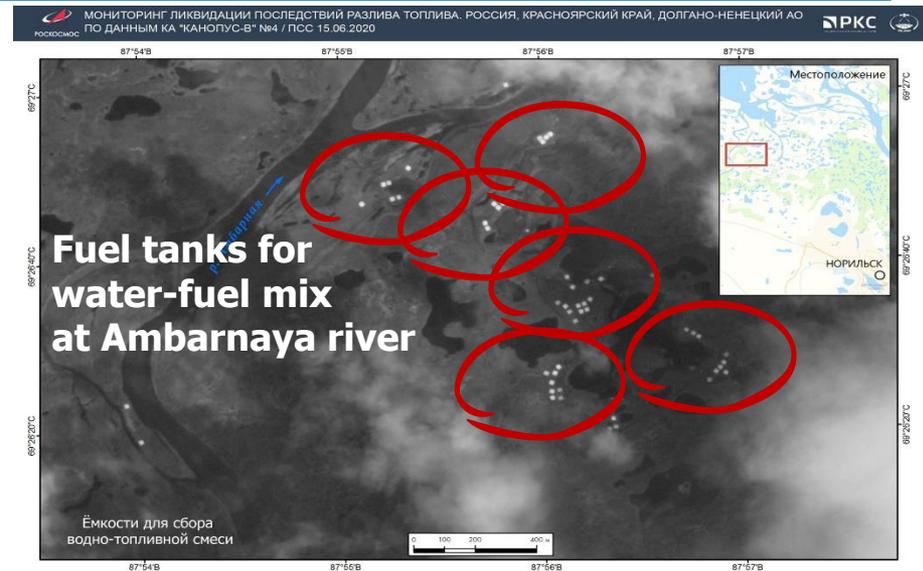
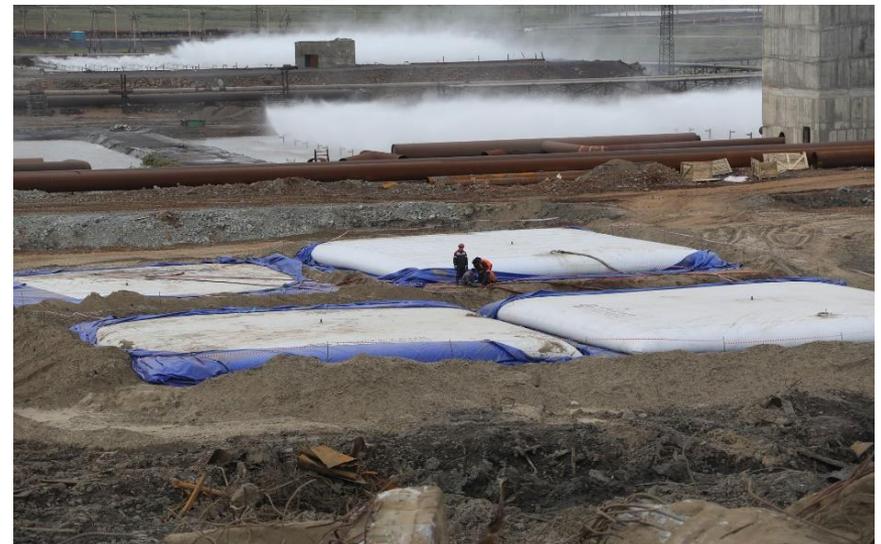
- **The water-fuel mixture collected from pits and sumps near HPP-3 and from Ambarnaya river was placed for storage into temporary fuel tanks**
 - ✓ Overall, 163 tanks were utilized for the storage

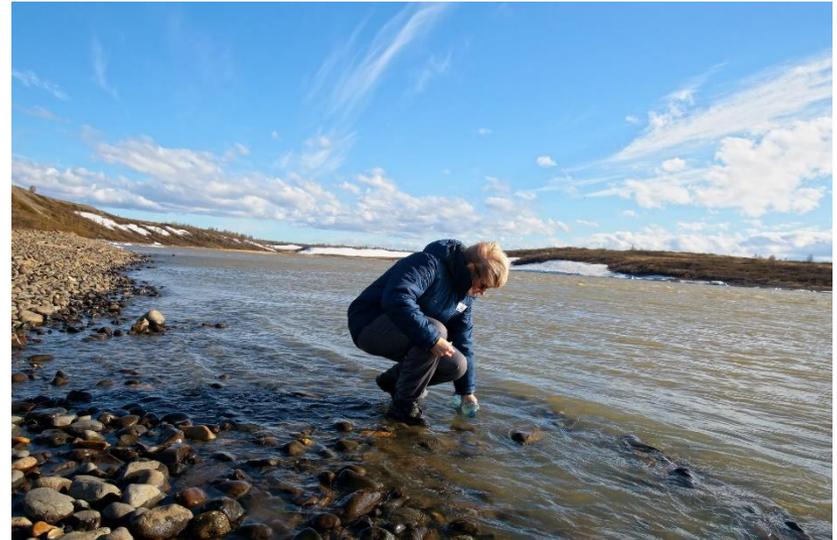
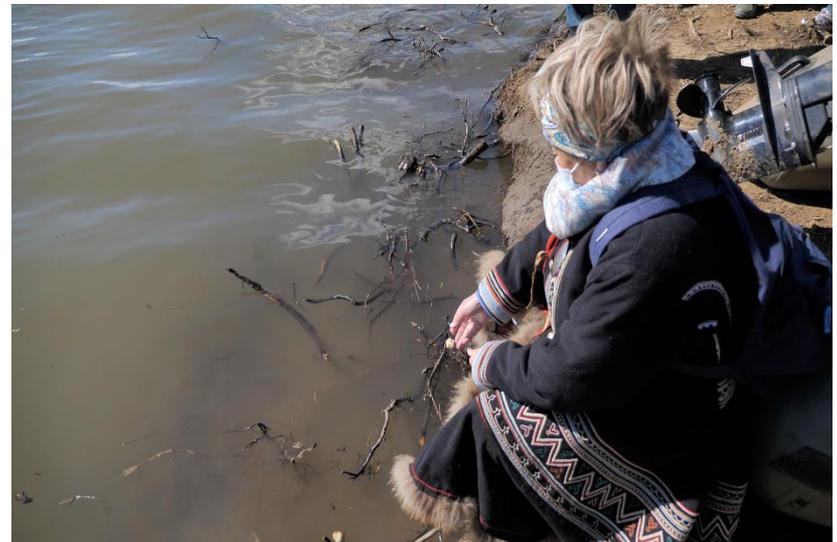
Transportation and Separation of Water-Fuel Mixture Collected from the Ambarnaya River

- **Transportation and separation of water-fuel mixture**
 - ✓ **Over 40 km of temporary pipelines were laid from the Ambarnaya river to a temporary storage facility near the Lebyazhye tailings dam**
 - ✓ By September, **all of the water-fuel mixture (25k cubic meters) collected from the river** was transported to temporary storage facilities near Norilsk
 - ✓ **All of the mixture was separated into water and fuel** with the help of high-capacity separator supplied by the Norwegian sea rescue service
 - ✓ After chemical analysis and further assessment, the recovered diesel will be utilized for heating purposes
 - ✓ The recovered water after further purification will be used as a technical water in closed water circuits of the Company's operations

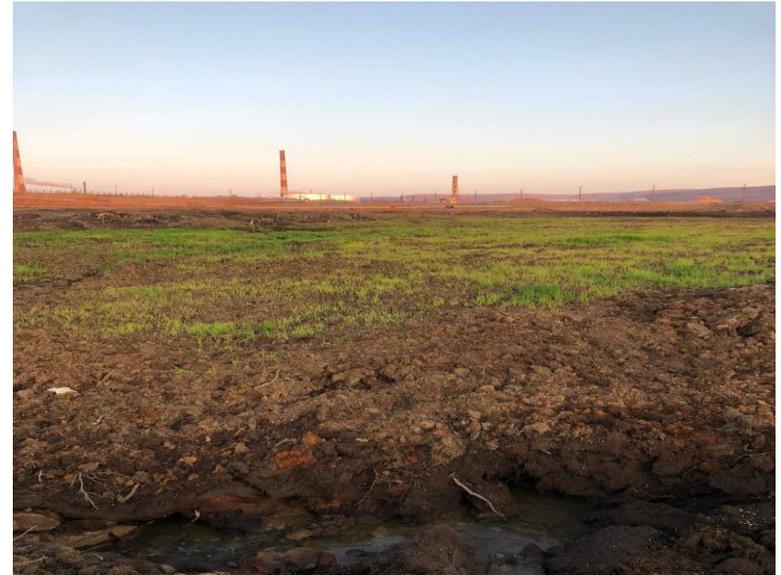
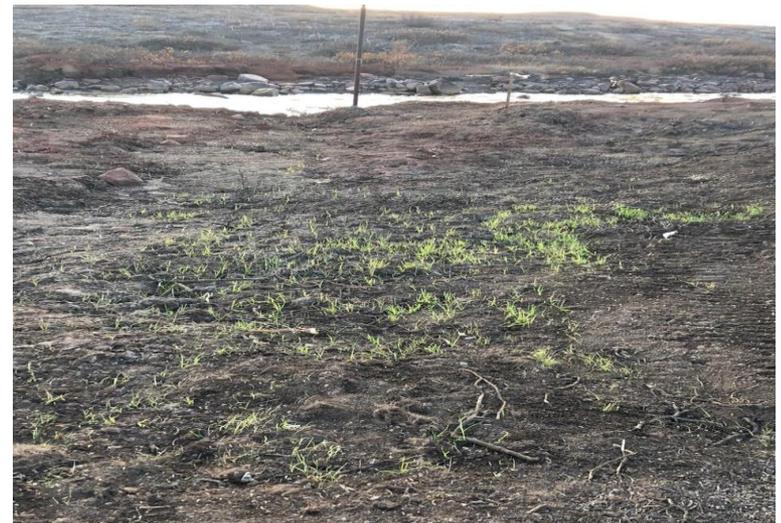
Area Rehabilitation and Restoration in Progress

- **Soil rehabilitation in the vicinity of HPP-3 in progress**
 - ✓ Replacing contaminated soil near HPP-3
 - ✓ Seeding grass at the impacted area
- **Rehabilitation of the coastline of the Ambarnaya river (as of end of September)**
 - ✓ A total of 489k sq m of land were treated with 121t of turf sorbents
 - ✓ Almost 1k of square meters of the coastline of Ambarnaya river and 21k square meters of the coastlines of the Bezymianny stream and Daldykan rivers were washed
 - ✓ The residues washed from the rivers' coastlines captured by 110 lines of absorbent boms
- **Collection of the fuel residues, washing and treatment of river shores with absorbent agents will continue until the start of the winter season of 2020**
 - ✓ Will resume in 2021 and 2022, as necessary

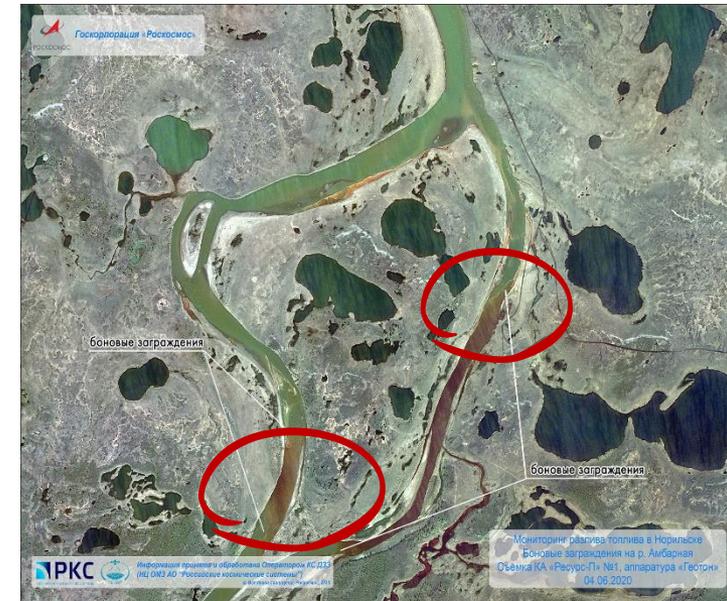
- **Satellite images published by Roskosmos on June 4th confirm that the oil spills were well contained in the Ambarnaya river**

- **Special containment booms have been installed in the Ambarnaya River**, which have prevented the spill from spreading to the downstream Pyasino Lake, including 40 lines of conventional containment booms and 79 lines of absorbing booms
- The spill has not reached Pyasino Lake
- There is no risk of pollution of the Kara Sea
- Regular aerial monitoring of the impacted area is carried out

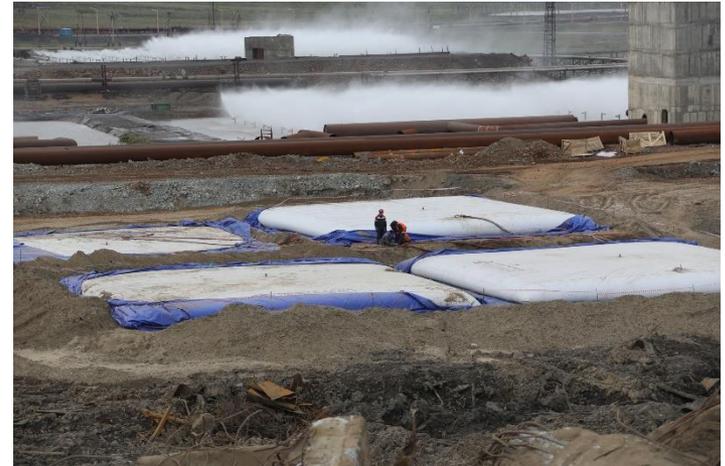
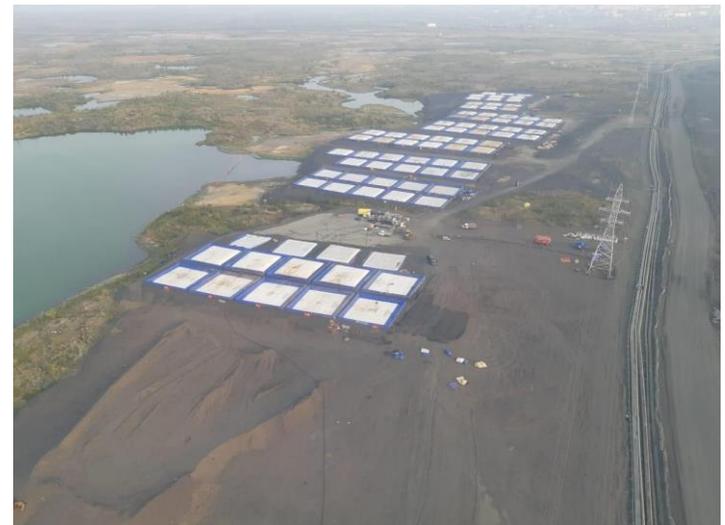
As of the end of September:

- ✓ **All of the contaminated soil was removed** (188kt) and hauled to disposal sites
- ✓ 35k cubic meters of water-fuel mixture has been collected near HHP-3 and from the Ambarnaya river
- ✓ 185.2 km of the coastline and 361,720 sq m of contaminated surface have been treated with sorbents

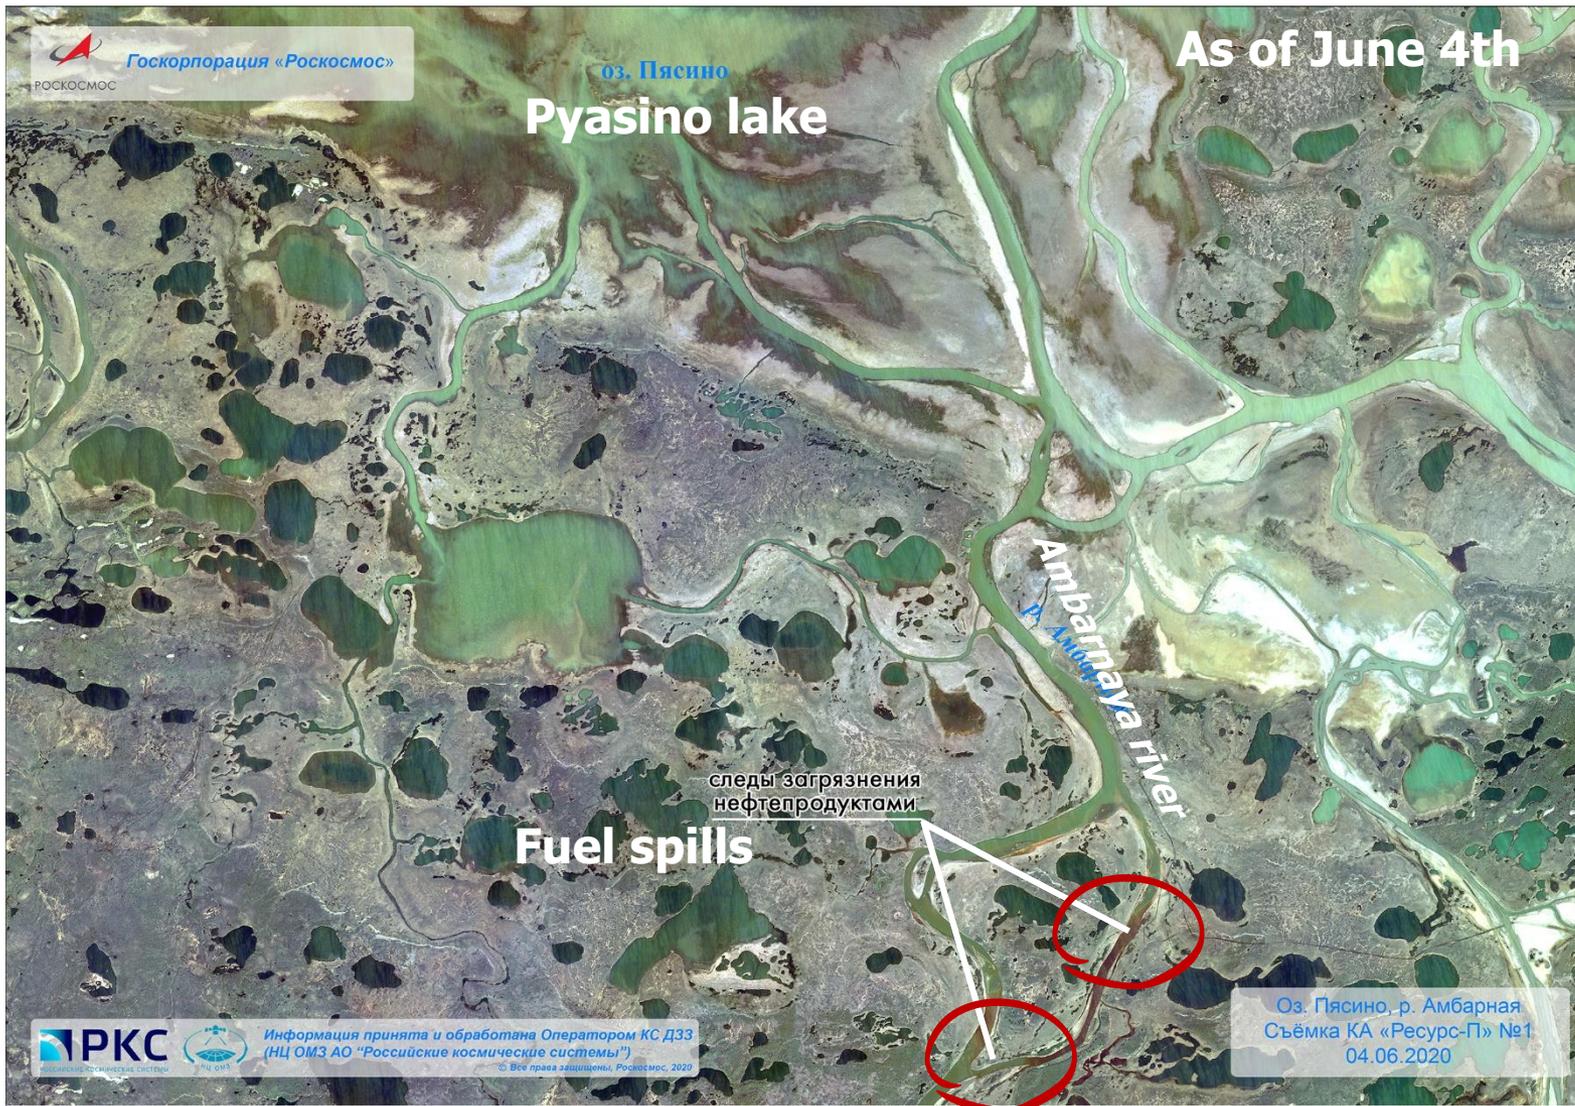
ROSKOSMOS Satellite Images of Norilsk-Pyasinsky Water System

Source: Company data, satellite images by ROSKOSMOS
